Manhole Inspection Summary

Manhole # S51K__021MH

Insp Date: **4/1/08 11:00 AM**

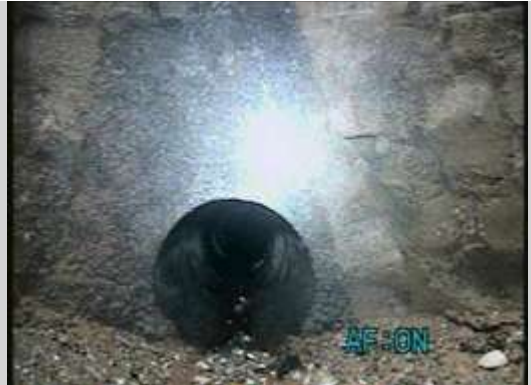
12 O'Clock Outflow

8 in. Circular Gravity Sewer
Pipe Out @ 12 O'Clock

Pipe Material: **Clay** ☐ Pipe Lined

Infiltration: **None** Pipe Seal Cond: **Unknown**
